Maritime archaeological  
site survey  
Huis te Warmelo 1708-1715.

Fieldwork report 2017-2018

**Maili Roio, Immi Wallin, Kari Hyttinen**

**Helsinki-Tallinn 2019**

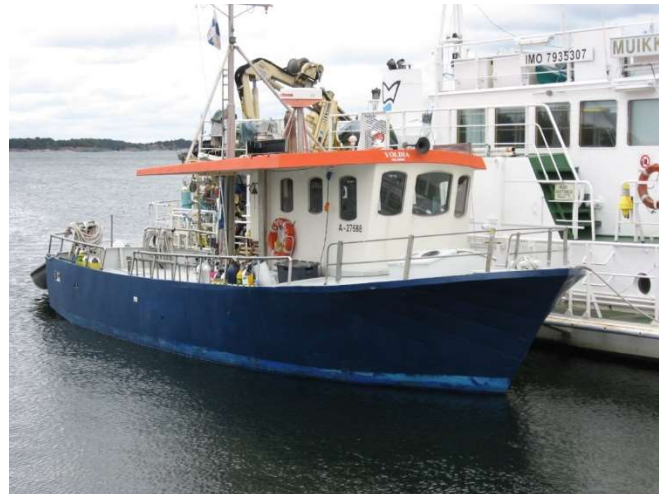
Length 12,2 m  
Beam 4 m  
Draft 1,7 m  
Gross Tons 19 T  
Engine Doosan L136 147kW Heavy Duty  
Communications, Navigation and Sounding Electronics:  
VHF Marine Radio (2), EBIRB, AIS A-Class, Radar (4kW antenna), DGPS,  
Autopilot Robertson AP-35, Depth Sounder (100-200 kHz), Side Scan Sonar  
(400/900 kHz), Deck crane Hiab 250, Life raft 10 pers., compressor for breathing  
air, breathing gas mixing system (Trimix)  
Side Scan Sonar  
DSME Sonar Beam UTech S-150S 400kHz

Fig. 1. The research vessel Yoldia. Photo: Immi Wallin.

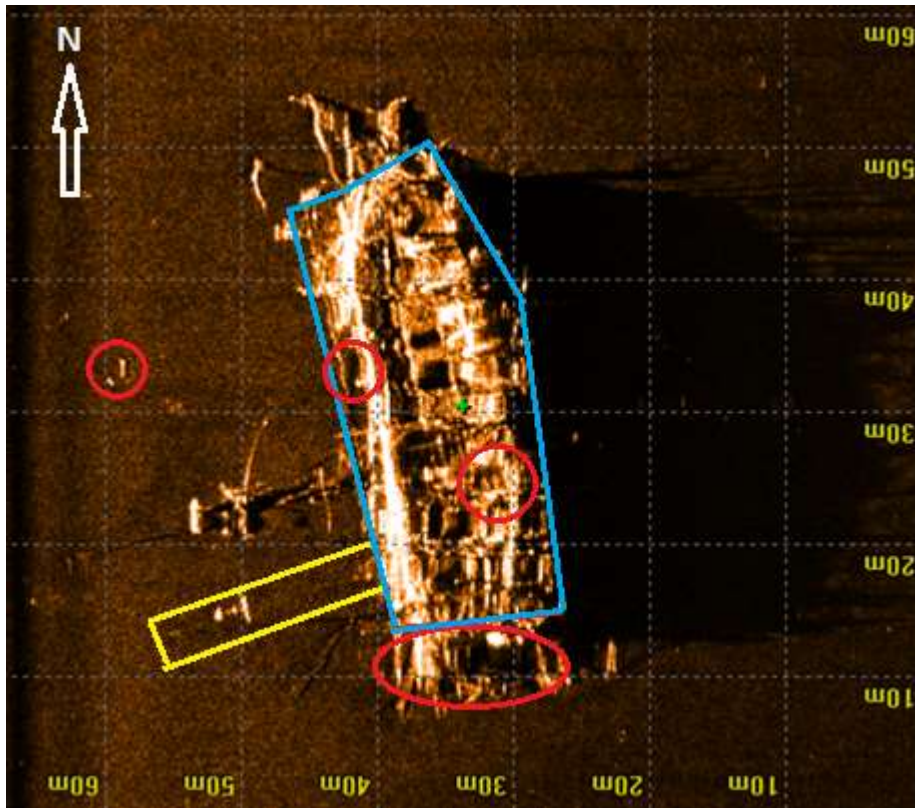
The dive teams included one camera man and 1-2 light divers carrying external video lights. Our target was to continue the 3D photogrammetry modelling of the wreck that we started in 2016. In 2017 and 2018 video shooting was done of the mizzen mast, main deck and port side at the bottom. Still photos were taken from part of mast that lies separately on the port side of the wreck, the pile of wooden parts behind the transom on the bottom and cannons on main deck starboard side. (Fig. 3).

Fig. 3. Documentation areas. Red: Still images, Yellow: videography of the Mizzen mast, Blue: videography for 3D photogrammetry. Image: Immi Wallin

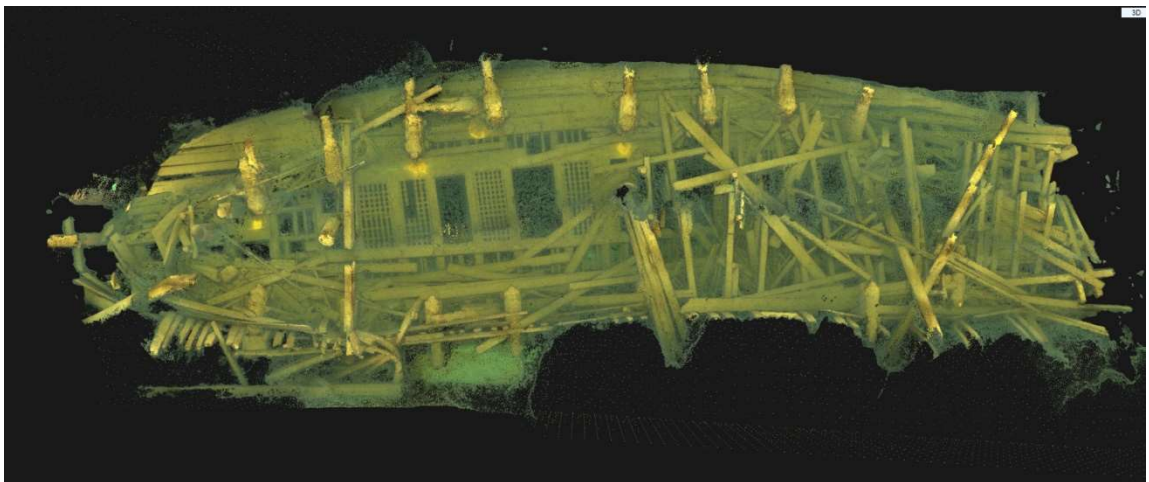
The 3D model of the wreck that was created of the data captured in 2016, was added with the data captured in 2017 and 2018. The 3D model of the wreck still needs more data to finalise the model.

The resulting 3D model has also some geometrical distortions and therefore it is not possible to get reliable measurements from the model at this stage.

However, 3D model of the main deck could be made (Fig. 5.).

Fig. 5. Image of 3D model of the main deck. Image: Kari Hyttinen.

The main task is to continue with 3D documentation and collect the high-quality data: recording the entire shipwreck site, artefacts and interior of the wreck. Collected material will be useful for the wreck monitoring in the future.

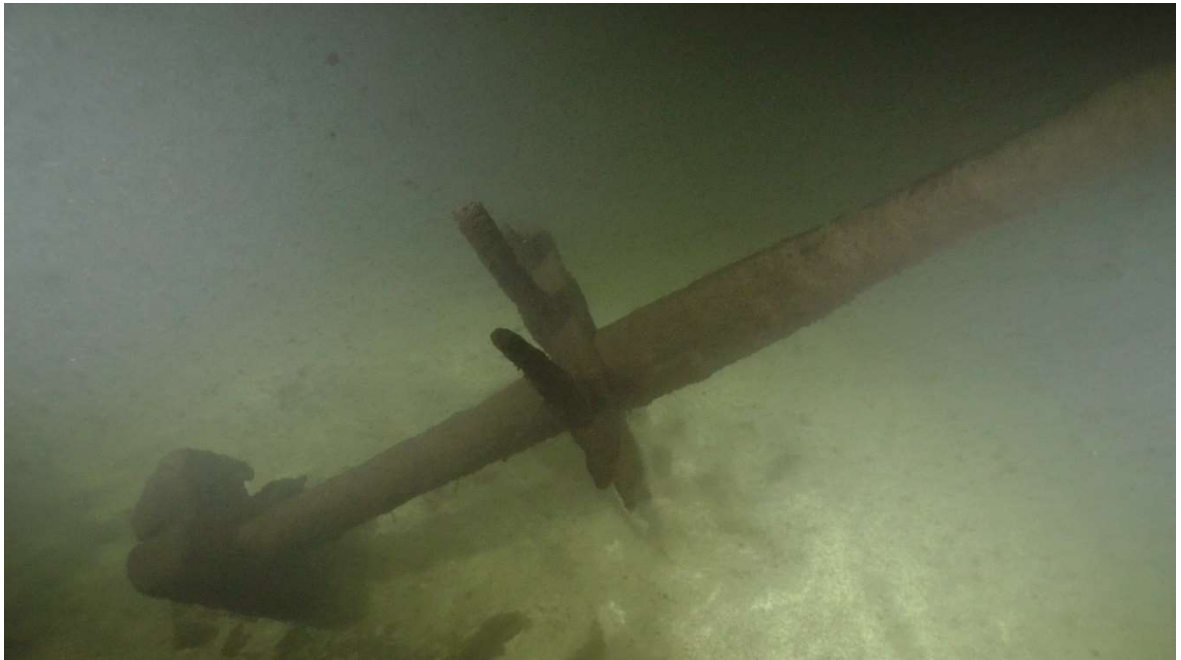
The mizzen mast that has fallen to the port side of the wreck, was documented by videography. The whole mast with two parts is attached on each other's and the cross trees are intact. The attachment of the mizzen mast and the mizzen top mast is also intact and shows the technique of the joint (Fig.6-10).

Fig. 6. Mizzen top mast with crosstrees and mastcap. Frame capture from video by Immi Wallin.

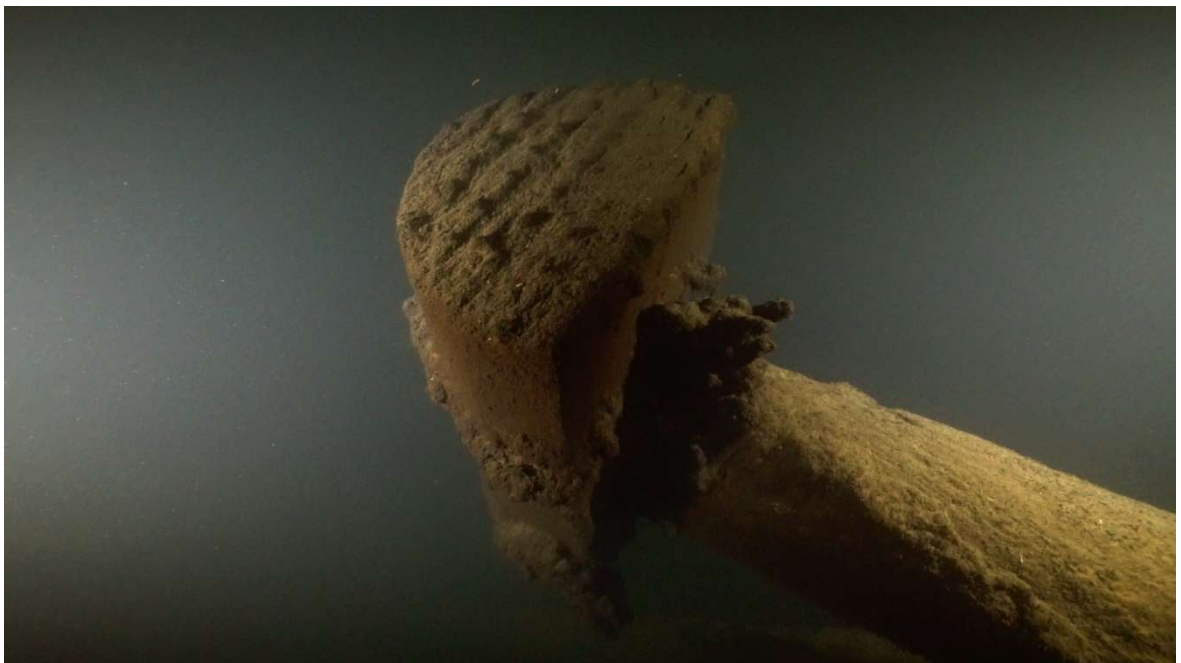
Fig. 7. Mizzen mastcap. Frame capture from video by Immi Wallin.

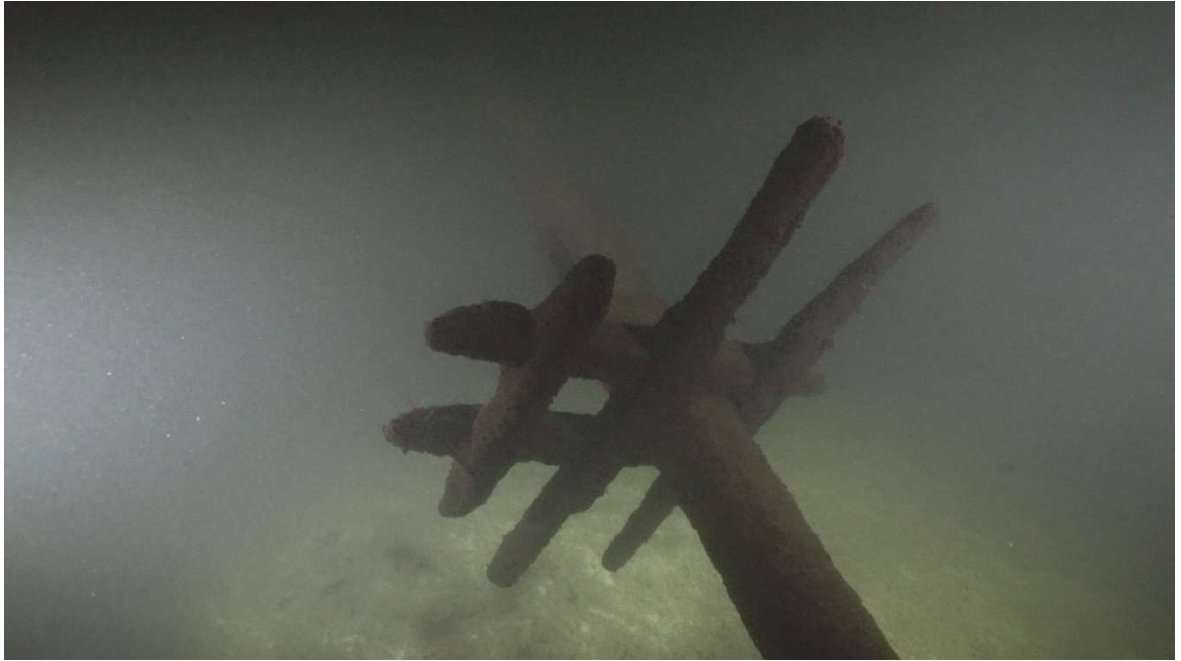
Fig. 8. Mizzen topmast crosstrees. Frame capture from video by Immi Wallin.

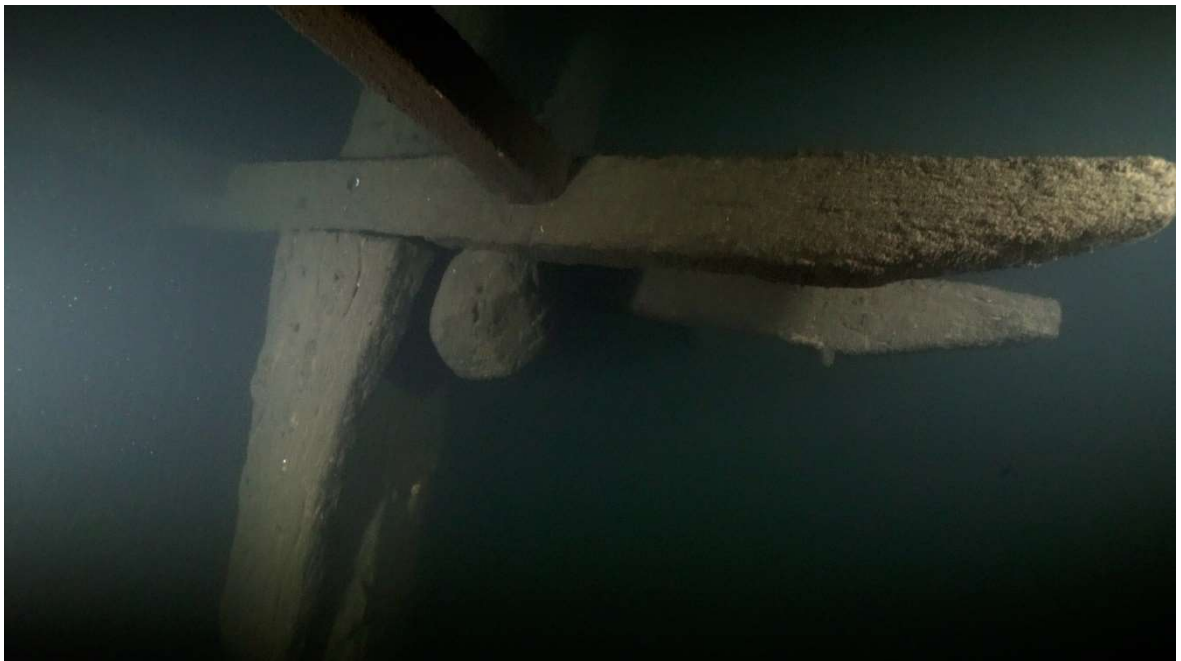
Fig. 9. Mizzen crosstrees and lower end of topmast. Frame capture from video by Immi Wallin.

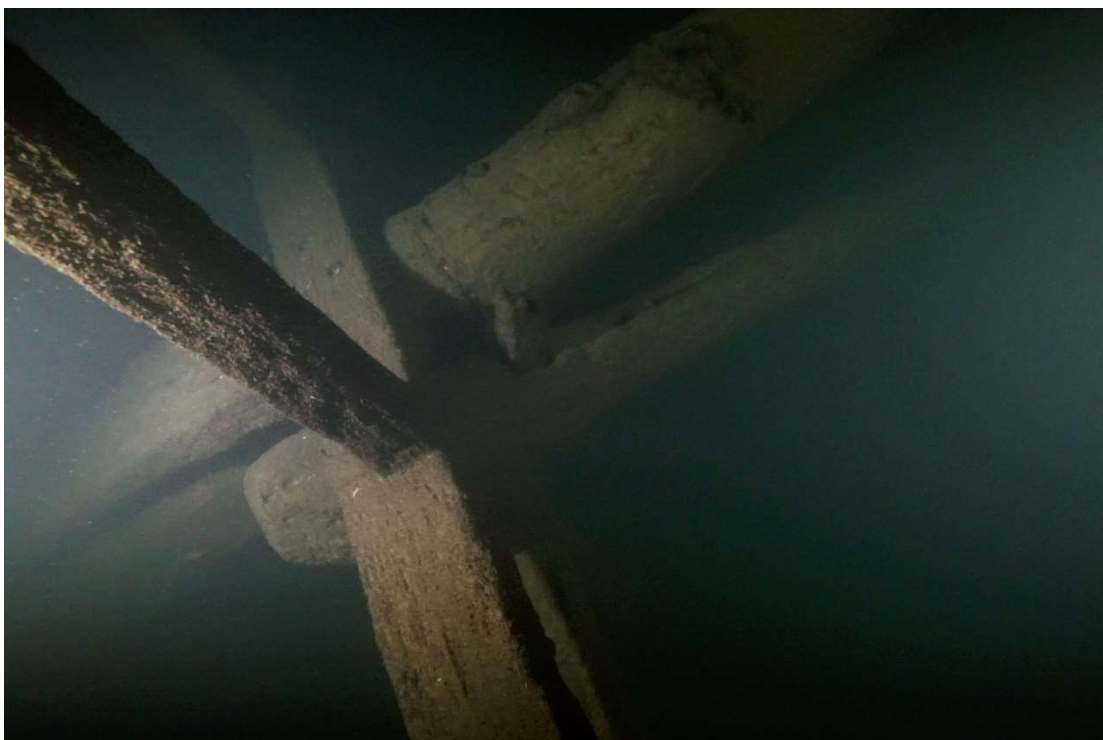
Fig. 10. Mizzen crosstrees and topmast. The chock that prevents the topmast to fall down thru the crosstrees, is also visible in the middle of the image. Frame capture from video by Immi Wallin.

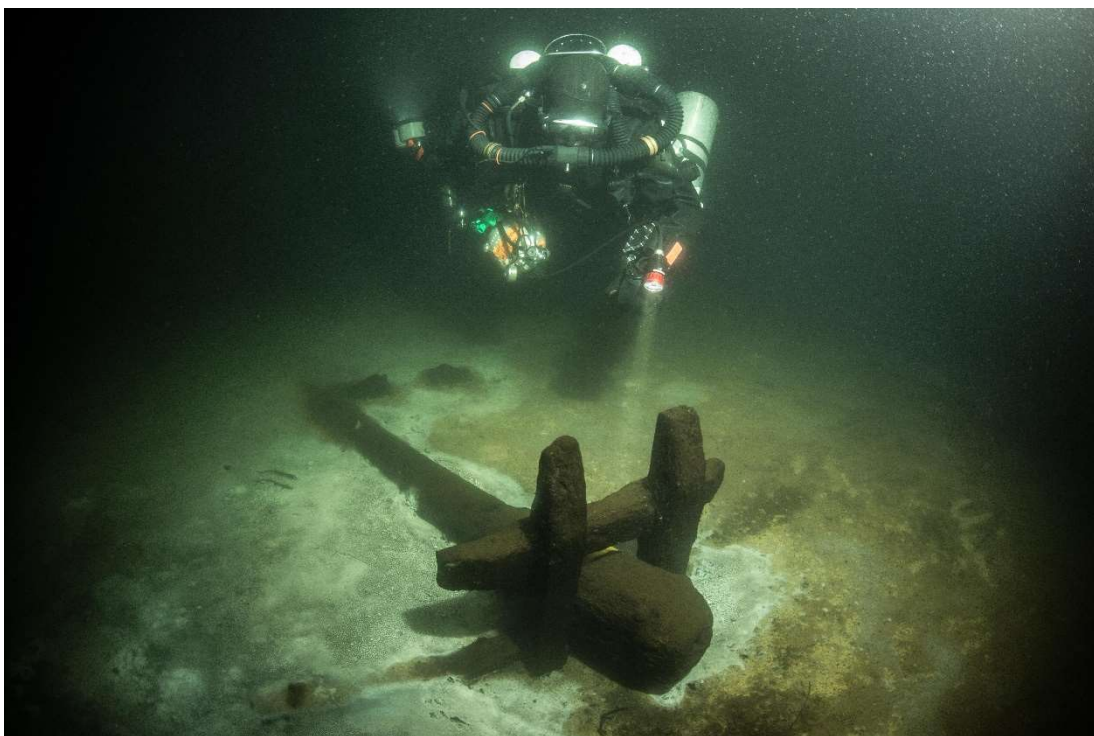
A single anomaly on the port side of the wreck in front of the fallen mainmast was photographed and identified. The anomaly appeared to most probably be the front topmast crosstree (fig. 11).

Fig. 11. The front topmast crosstree. Photo by Sami Paakkari.

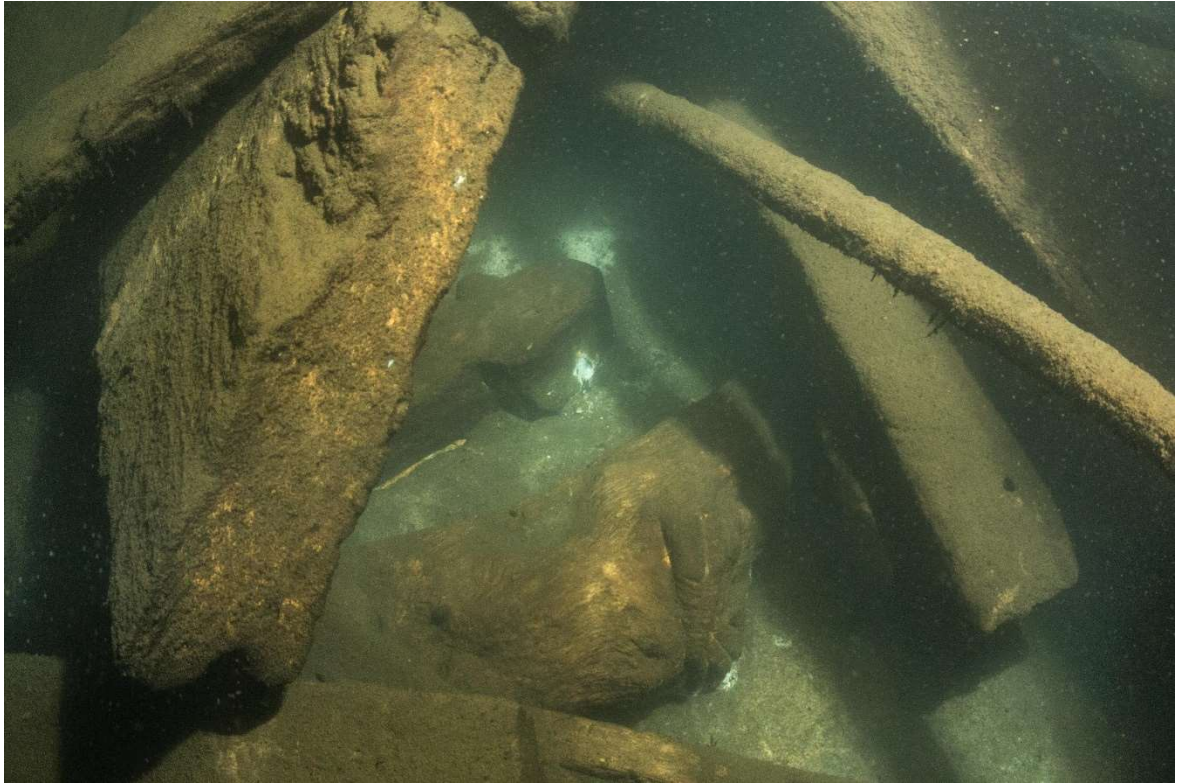
The aft part of the wreck that lays on the sea bottom, was photographed and it seems that there are more ornaments and decorations, but mostly their back side is visible (fig. 12-14).

Fig. 12. Decorations on the sea bottom behind the aft of the wreck. Photo by Sami Paakkari.

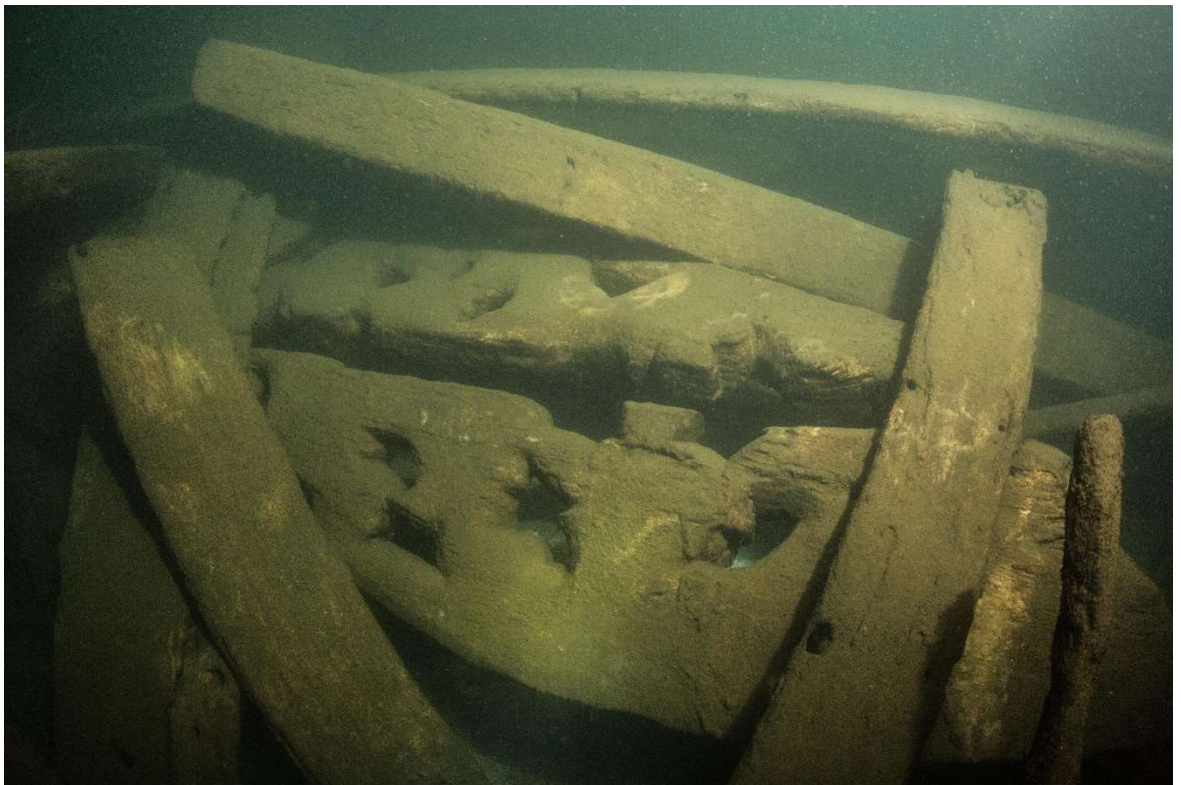
Fig. 13. Ornaments (back side of them) on the sea bottom behind the aft of the wreck.  
Photo by Sami Paakkari.

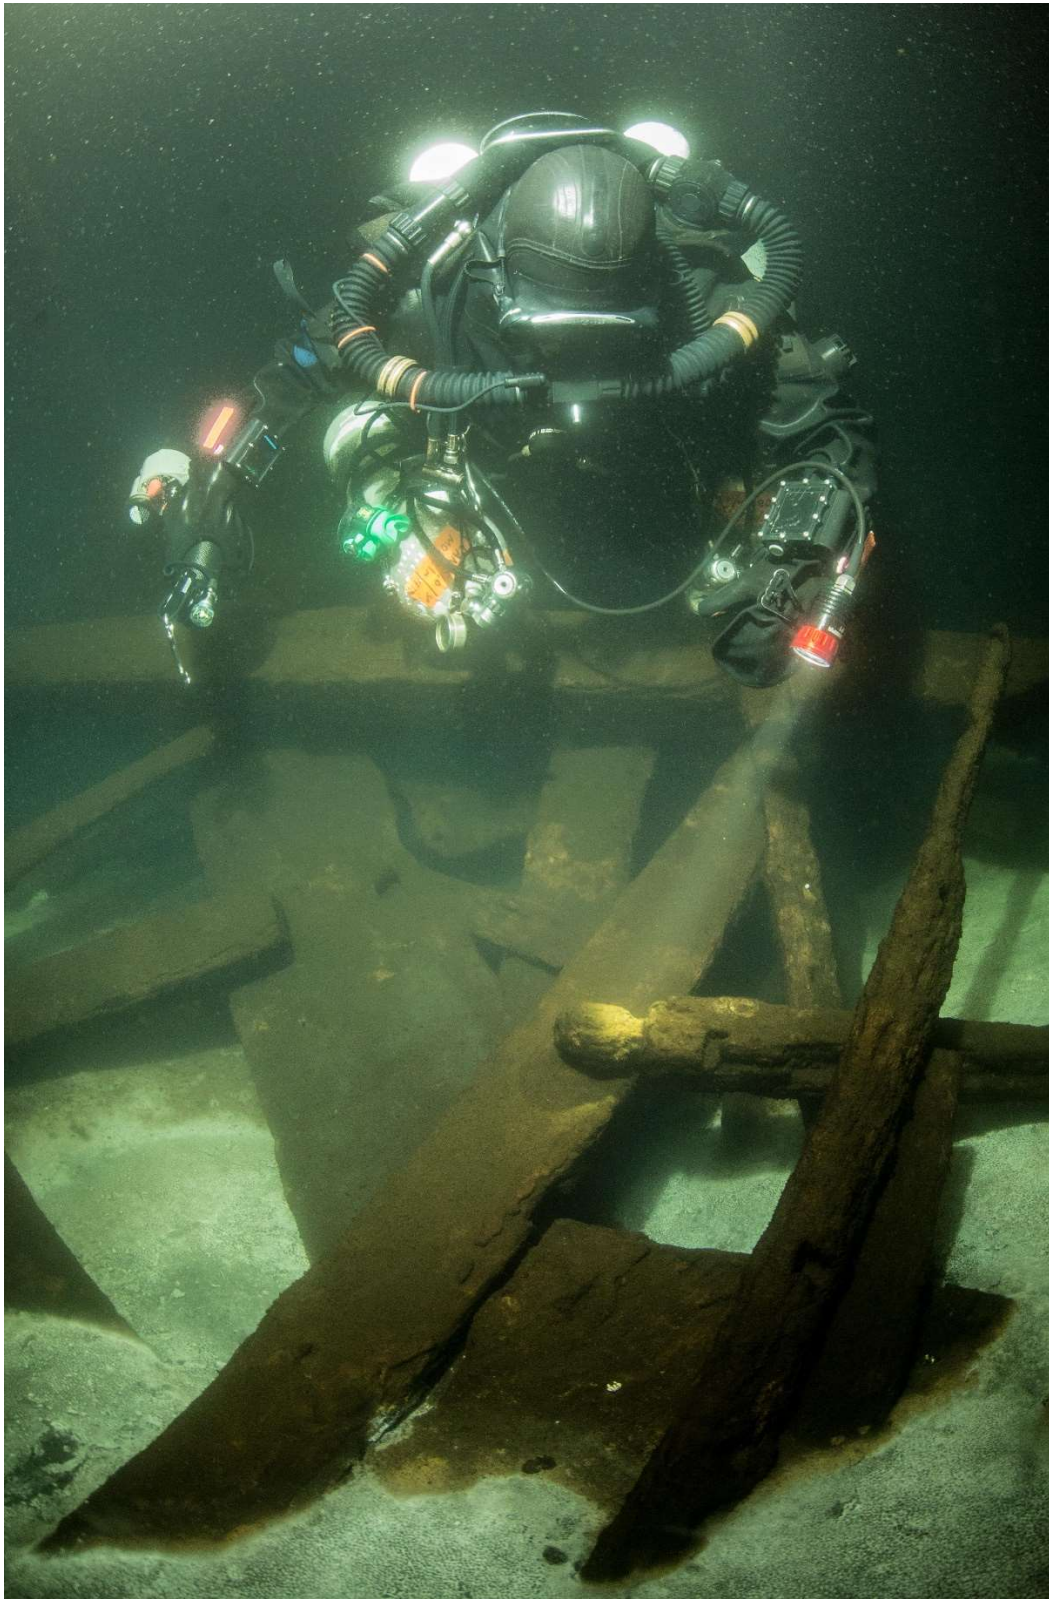
Fig. 14. Jenni Westerlund viewing parts of the aft castell that has fallen behind the aft of the wreck. Photo by Sami Paakkari.

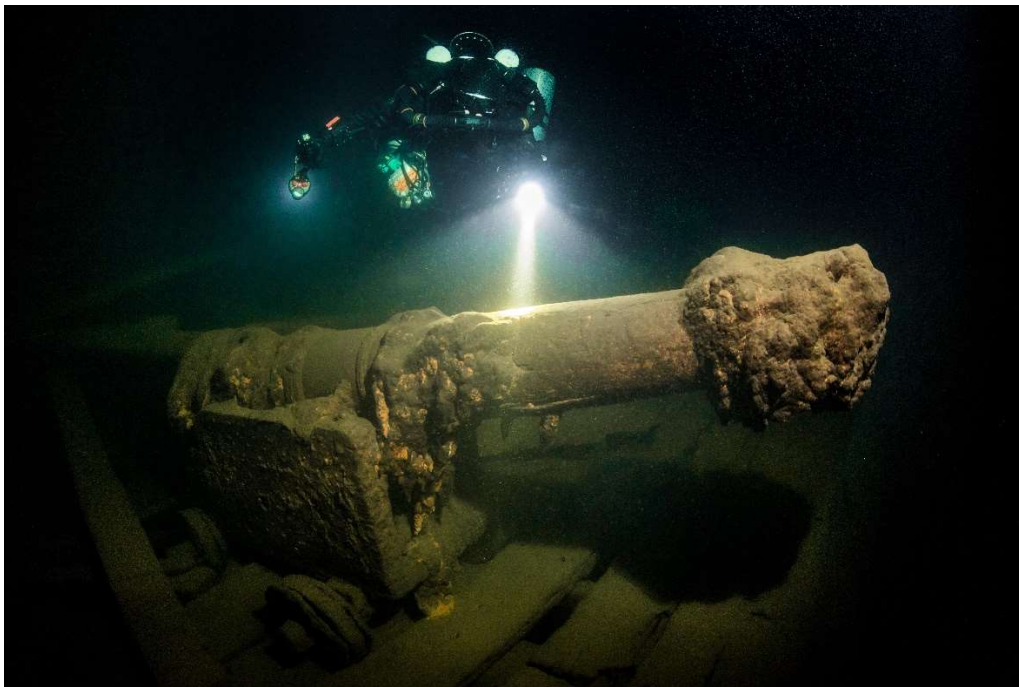
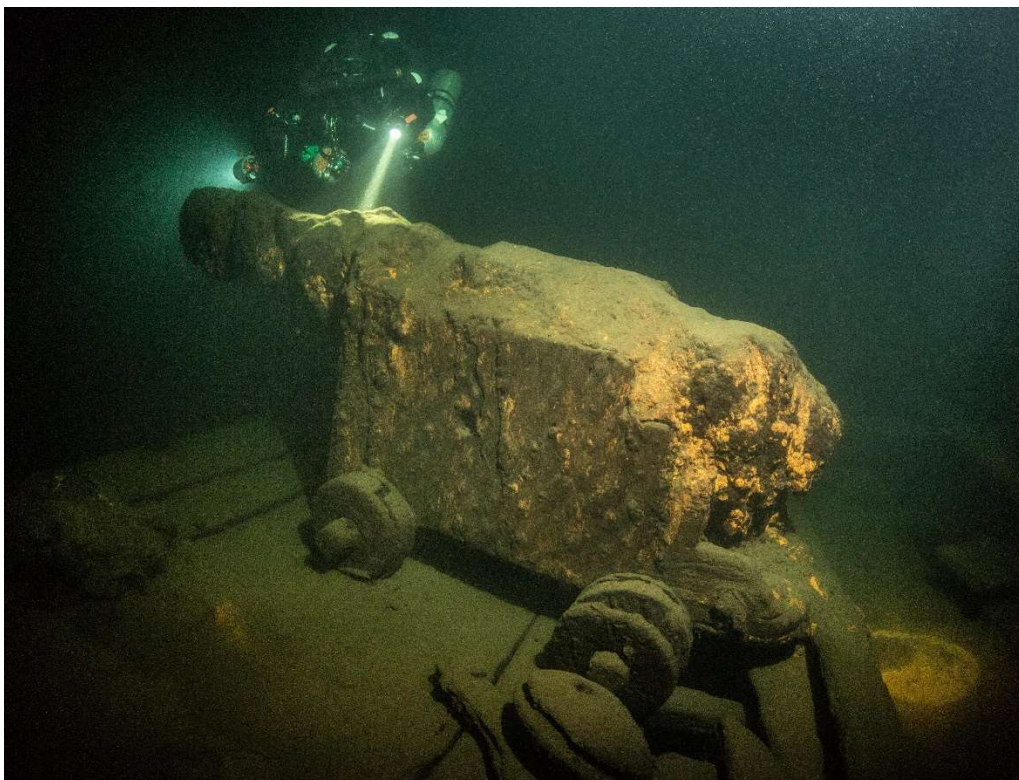
The cannons on the starboard side on the main deck were photographed with a diver. These photographs are showing the scale and can be used for presentations and articles (Fig. 15-16).

Fig. 15. Cannon and a diver on the main deck on starboard side. Photo by Sami Paakkari.

Fig. 16. Cannon and a diver on the main deck on starboard side. Photo by Sami Paakkari.
